**Flood Control Project Maintenance  
Levee Inspections**

**Maintenance Issue Types Only, Levee Inspection Report By Mile - Fall 2019**

**Sacramento Maintenance Yard Putah Creek**

Waterway	Bank	Unit Miles	Inspection Start/End	Inspector
Unit No. 01 Putah Creek or North Levee	Left	8.79	10/08/2019 10/08/2019	David Julian

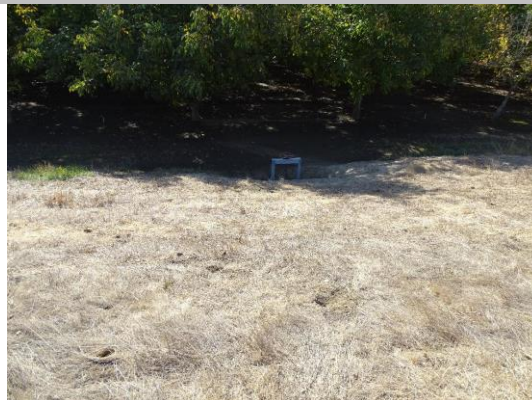
Photo 1 of 3 : UCIP\_FA\_2019\_55597\_82102.jpg

Comment Code					
Inspector Comment					
DS_ID:492 FS_ID:55597 EP_NO: 10262 Repair Type: Non-Urgent Crossing Status: Found UCIP Comments: 11/07/2019 No issues recorded during inspection (O.Yakimov - DWR UCIP) FIELD_STRUCT_DESC: 24-inch CIPP-lined drainage pipe of unknown material through levee, 13 feet below crown. Slide gate is located on the waterside (WS) end. Concrete headwalls are located on both the waterside (WS) and landside (LS). (24-inch pipe [HLM 2.77] authorized under Automatic Board Order (ABO) issued as Permit No. 10262, 1974 - Wells Fargo Bank, Trustee for S.H. Cowell Foundation) [Additional Reference(s): DWR Levee Log, 1981 and 2005 (HLM 2.77). USACE Sacramento O&M Manual, Unit 119, December 1952, Revised 29 Dec 2016, (Station P 213+00). USACE As-Built Drawing No. 50-04-2396, Revision 3, pdf page 22, Sheet 6, December 1947] FS Date: 11/7/2019 10:48:08 AM

View of WS looking from levee crown

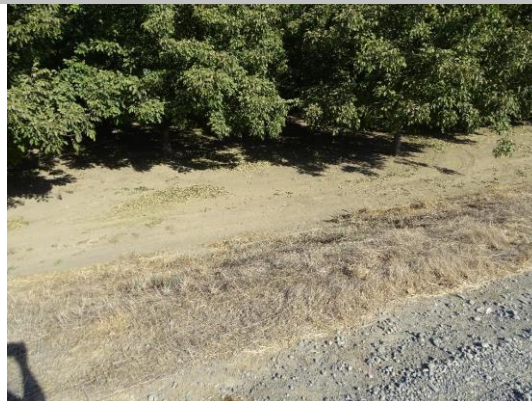
Photo 2 of 3 : UCIP\_FA\_2019\_55597\_82103.jpg

View of LS looking from levee crown

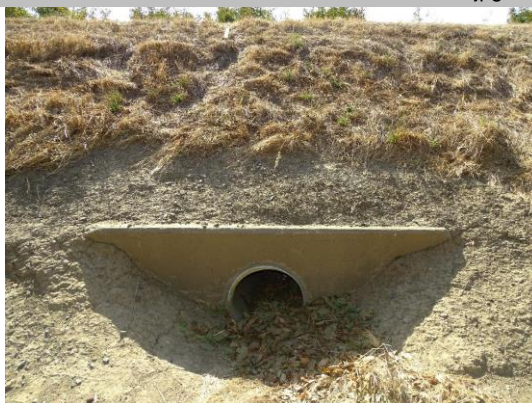
Photo 3 of 3 : UCIP\_FA\_2019\_55597\_82104.jpg

Comment Code						
Inspector Comment						
DS_ID:492 FS_ID:55597 EP_NO: 10262 Repair Type: Non-Urgent Crossing Status: Found UCIP Comments: 11/07/2019 No issues recorded during inspection (O.Yakimov - DWR UCIP) FIELD_STRUCT_DESC: 24-inch CIPP-lined drainage pipe of unknown material through levee, 13 feet below crown. Slide gate is located on the waterside (WS) end. Concrete headwalls are located on both the waterside (WS) and landside (LS). (24-inch pipe [HLM 2.77] authorized under Automatic Board Order (ABO) issued as Permit No. 10262, 1974 - Wells Fargo Bank, Trustee for S.H. Cowell Foundation) [Additional Reference(s): DWR Levee Log, 1981 and 2005 (HLM 2.77). USACE Sacramento O&M Manual, Unit 119, December 1952, Revised 29 Dec 2016, (Station P 213+00). USACE As-Built Drawing No. 50-04-2396, Revision 3, pdf page 22, Sheet 6, December 1947] FS Date: 11/7/2019 10:48:08 AM

LS levee slope, headwall, and pipe end

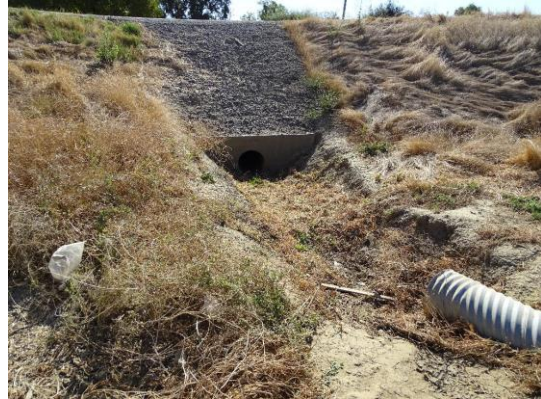
Photo 1 of 3 : UCIP\_FA\_2019\_55455\_81753.jpg

Comment Code					
Inspector Comment					
DS_ID:496					
FS_ID:55455					
EP_NO: 10251					
Repair Type: Non-Urgent					
Crossing Status: Found					
UCIP Comments: 10/22/2019 Installed a new precast concrete box on the waterside. Pipe will be lined in November 2019 according to FMO staff. (O.Yakimov - DWR UCIP)4/10/2019 Major erosion through out pipe. Erosion on WS allows water to enter pipe and flood LS field. Erosion on farmers waterman valve. Field water drains into pipe and floods LS field. (J.McCabe - DWR Sacramento Yard)					
FIELD_STRUCT_DESC: 24-inch corrugated metal drainage pipe through levee, 15 feet below the crown. Two metal cutoff walls were installed through the levee. A T-post and T-handle are located on the landside (LS) toe. The outfall structure and flap gate are located on the west side of bridge, waterside (WS). (24-inch pipe [HLM 3.87] authorized under Automatic Board Order (ABO) issued as Permit No. 10251, 1974 - F.M.C. Corp.) [Additional Reference(s): DWR Levee Log, 1981 and 2005 (HLM 3.87). USACE Sacramento O&M Manual, Unit 119, December 1952, Revised 29 Dec 2016, (Station 1+50 PCT). USACE As-Built Drawing No. 50-04-2396, Revision 4, pdf page 23, Sheet 7, December 1947]

LS levee slope, headwall, and pipe end

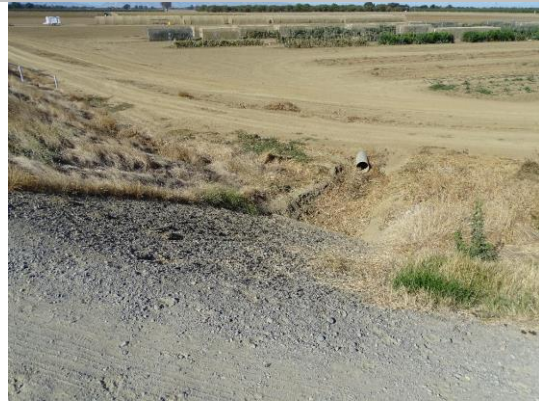
Photo 3 of 3 : UCIP\_FA\_2019\_55455\_81755.jpg

Comment Code						
Inspector Comment						
DS_ID:496						
FS_ID:55455						
EP_NO: 10251						
Repair Type: Non-Urgent						
Crossing Status: Found						
UCIP Comments: 10/22/2019 Installed a new precast concrete box on the waterside. Pipe will be lined in November 2019 according to FMO staff. (O.Yakimov - DWR UCIP)4/10/2019 Major erosion through out pipe. Erosion on WS allows water to enter pipe and flood LS field. Erosion on farmers waterman valve. Field water drains into pipe and floods LS field. (J.McCabe - DWR Sacramento Yard)						
FIELD_STRUCT_DESC: 24-inch corrugated metal drainage pipe through levee, 15 feet below the crown. Two metal cutoff walls were installed through the levee. A T-post and T-handle are located on the landside (LS) toe. The outfall structure and flap gate are located on the west side of bridge, waterside (WS). (24-inch pipe [HLM 3.87] authorized under Automatic Board Order (ABO) issued as Permit No. 10251, 1974 - F.M.C. Corp.) [Additional Reference(s): DWR Levee Log, 1981 and 2005 (HLM 3.87). USACE Sacramento O&M Manual, Unit 119, December 1952, Revised 29 Dec 2016, (Station 1+50 PCT). USACE As-Built Drawing No. 50-04-2396, Revision 4, pdf page 23, Sheet 7, December 1947]

View of LS looking from levee crown

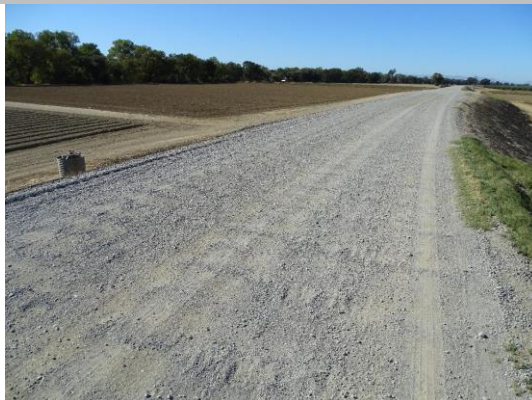
Photo 1 of 3 : UCIP\_FA\_2019\_55456\_81760.jpg

DS\_ID:497  
FS\_ID:55456  
EP\_NO: 10251  
Repair Type: Non-Urgent  
Crossing Status: Found  
UCIP Comments: 10/22/2019 Pipe inlet and headwall are not visible on LS. Slide gate in CMP riser is in closed position, crossing looks abandoned. Construction according to permit 10251-1 hasn't started yet. Field structure description is updated to match original pipe construction. (O.Yakimov - DWR UCIP)  
FIELD\_STRUCT\_DESC: 24-inch pipe through levee, 16 feet below the crown. 36-inch galvanized corrugated metal pipe (CMP) riser located on the waterside (WS) slope. (24-inch pipe [HLM 4.13] authorized under Automatic Board Order (ABO) issued as Permit No. 10251, 1974 - F.M.C. Corp.; assumed original 24-inch pipe was installed in 12/12/1952 per O&M manual) [Additional Reference(s): DWR Levee Log, 1981 and 2005 (HLM 4.13). USACE Sacramento O&M Manual, Unit 119, December 1952, Revised 29 Dec 2016, (Station 17+00 PCT). USACE As-Built Drawing No. 50-04-2396, Revision 4, pdf page 23, Sheet 7, December 1947]

View of levee crown at the crossing

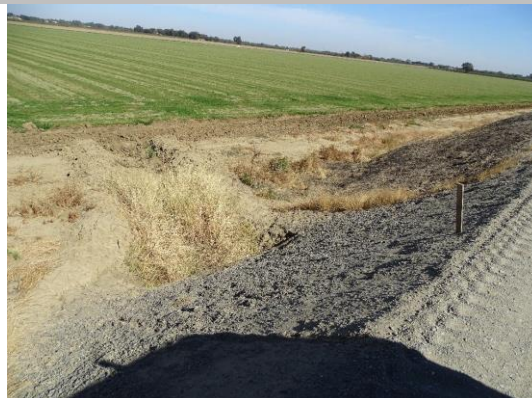
Photo 1 of 3 : UCIP\_FA\_2019\_55459\_81775.jpg

Comment Code						
Inspector Comment						
DS_ID:500 FS_ID:55459 EP_NO: 10256 Repair Type: Non-Urgent Crossing Status: Found UCIP Comments: 10/22/2019 No issues recorded during inspection (O.Yakimov - DWR UCIP)05/06/2013 Debris removed. See picture (C. Lund - DWR Sacramento Yard) 04/04/2012 Some debris in pipe invert LS (W. Wylie - DWR UCIP) FIELD_STRUCT_DESC: 24-inch CIPP-lined corrugated metal drainage pipe through the levee, 15 feet below the crown. Slide gate on the waterside (WS) end. Concrete headwall on the landside (LS) end. (24-inch pipe [HLM 5.39] authorized under Automatic Board Order (ABO) issued as Permit No. 10256, 1974 - Albert H. Lederer). [Additional Reference(s): DWR Levee Log, 2005 (HLM 5.39). USACE Sacramento O&M Manual, Unit 119, December 1952, Revised 29 Dec 2016, (Station 83+70 PCT). USACE As-Built Drawing No. 50-04-2396, Revision 4, pdf page 24, Sheet 8, December 1947]. FS Date: 10/22/2019 3:11:16 PM

View of LS looking from levee crown

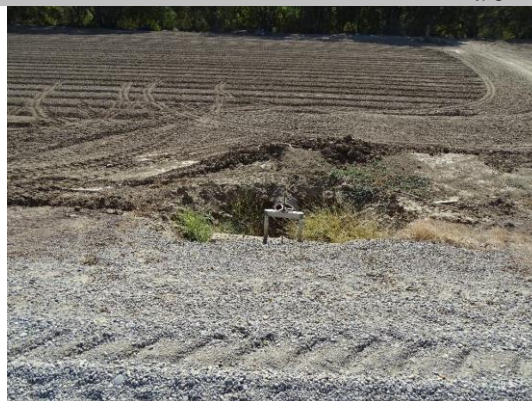
Photo 2 of 3 : UCIP\_FA\_2019\_55459\_81776.jpg

View of WS looking from levee crown

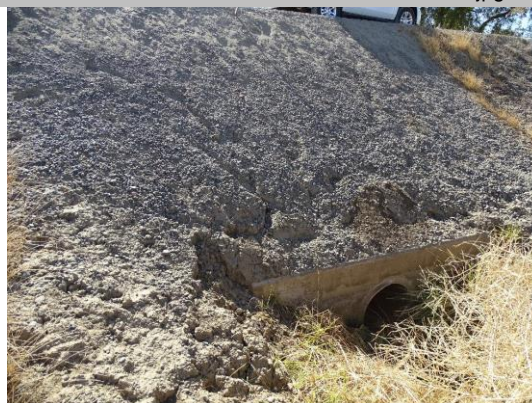
Photo 3 of 3 : UCIP\_FA\_2019\_55459\_81777.jpg

Comment Code						
Inspector Comment						
DS_ID:500 FS_ID:55459 EP_NO: 10256 Repair Type: Non-Urgent Crossing Status: Found UCIP Comments: 10/22/2019 No issues recorded during inspection (O.Yakimov - DWR UCIP)05/06/2013 Debris removed. See picture (C. Lund - DWR Sacramento Yard) 04/04/2012 Some debris in pipe invert LS (W. Wylie - DWR UCIP) FIELD_STRUCT_DESC: 24-inch CIPP-lined corrugated metal drainage pipe through the levee, 15 feet below the crown. Slide gate on the waterside (WS) end. Concrete headwall on the landside (LS) end. (24-inch pipe [HLM 5.39] authorized under Automatic Board Order (ABO) issued as Permit No. 10256, 1974 - Albert H. Lederer). [Additional Reference(s): DWR Levee Log, 2005 (HLM 5.39). USACE Sacramento O&M Manual, Unit 119, December 1952, Revised 29 Dec 2016, (Station 83+70 PCT). USACE As-Built Drawing No. 50-04-2396, Revision 4, pdf page 24, Sheet 8, December 1947]. FS Date: 10/22/2019 3:11:16 PM

LS levee slope, headwall, and pipe end

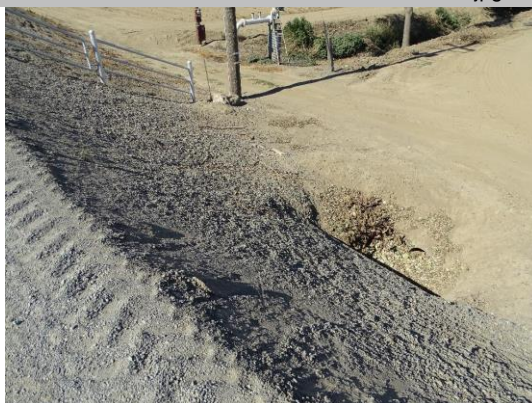
Photo 1 of 3 : UCIP\_FA\_2019\_55461\_81782.jpg

Comment Code					
Inspector Comment					
DS_ID:502 FS_ID:55461 EP_NO: 10255 Repair Type: Non-Urgent Crossing Status: Found UCIP Comments: 10/22/2019 No issues recorded during inspection (O.Yakimov - DWR UCIP) FIELD_STRUCT_DESC: 24-inch CIPP-lined corrugated metal drainage pipe through the levee, 11 feet below the crown. Slide gate on the waterside (WS) end. Concrete headwall on the landside (LS) end. (24-inch pipe [HLM 5.67] authorized under Automatic Board Order (ABO) issued as Permit No. 10255, 1974 - Owen W. and Ray W. Hamel). [Additional Reference(s): DWR Levee Log, 2005 (HLM 5.67). USACE Sacramento O&M Manual, Unit 119, December 1952, Revised 29 Dec 2016, (Station 97+00 PCT). USACE As-Built Drawing No. 50-04-2396, Revision 4, pdf page 24, Sheet 8, December 1947]. FS Date: 10/22/2019 4:03:27 PM

View of LS looking from levee crown

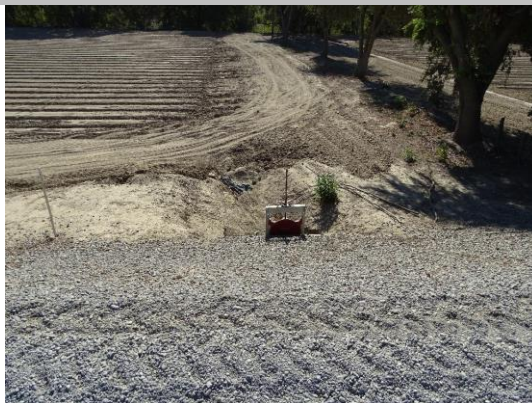
Photo 2 of 3 : UCIP\_FA\_2019\_55461\_81783.jpg

View of WS looking from levee crown

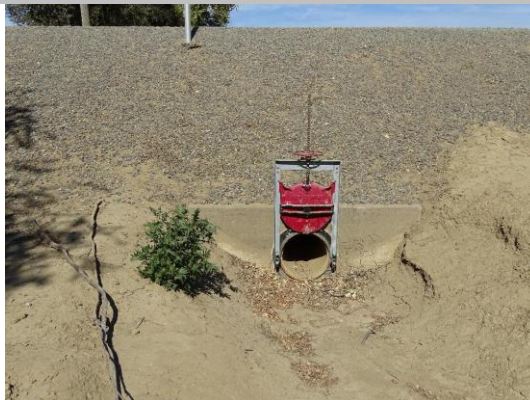
Photo 3 of 3 : UCIP\_FA\_2019\_55461\_81784.jpg

Comment Code						
Inspector Comment						
DS_ID:502 FS_ID:55461 EP_NO: 10255 Repair Type: Non-Urgent Crossing Status: Found UCIP Comments: 10/22/2019 No issues recorded during inspection (O.Yakimov - DWR UCIP) FIELD_STRUCT_DESC: 24-inch CIPP-lined corrugated metal drainage pipe through the levee, 11 feet below the crown. Slide gate on the waterside (WS) end. Concrete headwall on the landside (LS) end. (24-inch pipe [HLM 5.67] authorized under Automatic Board Order (ABO) issued as Permit No. 10255, 1974 - Owen W. and Ray W. Hamel). [Additional Reference(s): DWR Levee Log, 2005 (HLM 5.67). USACE Sacramento O&M Manual, Unit 119, December 1952, Revised 29 Dec 2016, (Station 97+00 PCT). USACE As-Built Drawing No. 50-04-2396, Revision 4, pdf page 24, Sheet 8, December 1947]. FS Date: 10/22/2019 4:03:27 PM

WS levee slope, headwall, and slide gate

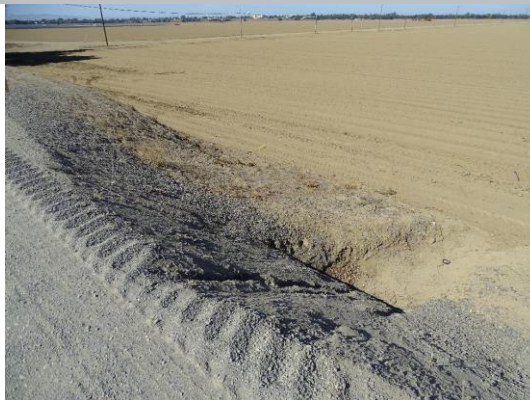
Photo 1 of 3 : UCIP\_FA\_2019\_55644\_82261.jpg

Comment Code					
Inspector Comment					
DS_ID:503 FS_ID:55644 EP_NO: 10252 Repair Type: Non-Urgent Crossing Status: Found UCIP Comments: 10/22/2019 No issues recorded during inspection (O.Yakimov - DWR UCIP)05/06/2013 owner of pipe needs to clean out obstruction in pipe. (C. Lund - DWR Sacramento Yard) 04/04/2012 Partially obstructed with sedimentation throughout crossing. (W. Wylie - DWR UCIP) FIELD_STRUCT_DESC: 24-inch CIPP-lined corrugated metal drainage pipe through the levee, 12 feet below the crown. Slide gate on the waterside (WS) end. Concrete headwall on the landside (LS) end. (24-inch pipe [HLM 5.86] authorized under Automatic Board Order (ABO) issued as Permit No. 10252, 1974 - John F. Hamel). [Additional Reference(s): DWR Levee Log, 2005 (HLM 5.86). USACE Sacramento O&M Manual, Unit 119, December 1952, Revised 29 Dec 2016, (Station 108+00 PCT). USACE As-Built Drawing No. 50-04-2396, Revision 4, pdf page 24, Sheet 8, December 1947]. FS Date: 10/22/2019 10:55:40 AM

View of LS looking from levee crown

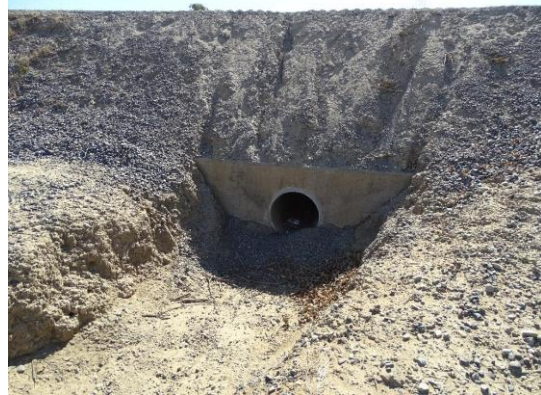
Photo 3 of 3 : UCIP\_FA\_2019\_55644\_82263.jpg

Comment Code						
Inspector Comment						
DS_ID:503 FS_ID:55644 EP_NO: 10252 Repair Type: Non-Urgent Crossing Status: Found UCIP Comments: 10/22/2019 No issues recorded during inspection (O.Yakimov - DWR UCIP)05/06/2013 owner of pipe needs to clean out obstruction in pipe. (C. Lund - DWR Sacramento Yard) 04/04/2012 Partially obstructed with sedimentation throughout crossing. (W. Wylie - DWR UCIP) FIELD_STRUCT_DESC: 24-inch CIPP-lined corrugated metal drainage pipe through the levee, 12 feet below the crown. Slide gate on the waterside (WS) end. Concrete headwall on the landside (LS) end. (24-inch pipe [HLM 5.86] authorized under Automatic Board Order (ABO) issued as Permit No. 10252, 1974 - John F. Hamel). [Additional Reference(s): DWR Levee Log, 2005 (HLM 5.86). USACE Sacramento O&M Manual, Unit 119, December 1952, Revised 29 Dec 2016, (Station 108+00 PCT). USACE As-Built Drawing No. 50-04-2396, Revision 4, pdf page 24, Sheet 8, December 1947]. FS Date: 10/22/2019 10:55:40 AM

LS levee slope, headwall, and pipe end

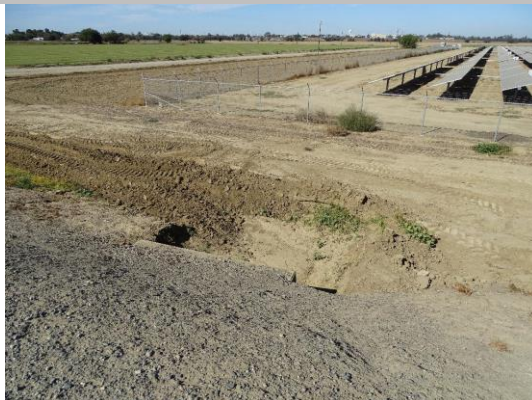
Photo 1 of 3 : UCIP\_FA\_2019\_55647\_82273.jpg

Comment Code						
Inspector Comment						
DS_ID:505 FS_ID:55647 EP_NO: 10253 Repair Type: Non-Urgent Crossing Status: Found UCIP Comments: 10/22/2019 Levee toe erosion on both sides of headwall on WS. (O.Yakimov - DWR UCIP) FIELD_STRUCT_DESC: 24-inch CIPP-lined corrugated metal drainage pipe through the levee, 10.4 feet below the crown. Slide gate on the waterside (WS), and concrete headwalls on both the WS and the landside (LS). (24-inch pipe [HLM 6.57] authorized under Automatic Board Order (ABO) issued as Permit No. 10253, 1974 - Lester J. Hamel). [Additional Reference(s): DWR Levee Log, 2005 (HLM 6.57. USACE Sacramento O&M Manual, Unit 119, December 1952, Revised 29 Dec 2016, (Station 145+50 PCT). USACE As-Built Drawing No. 50-04-2396, Revision 4, pdf page 24, Sheet 8, December 1947]. FS Date: 10/22/2019 11:07:35 AM

View of LS looking from levee crown

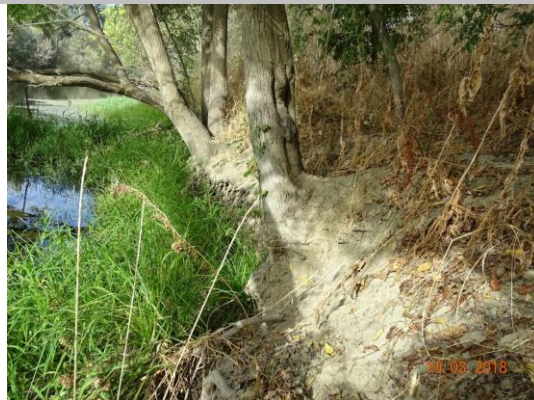
Photo 1 of 1 : FA\_2019\_ST0007\_282\_34\_20190826\_00006.jpg

LM Start	6.88	Rating **	M	Issue No.	34
LM End	6.93	Issue Type +	Ma	Location *	WS
Category	Supplemental			GPS Latitude/Longitude	
				Start	End
Item	2017 USACE Erosion Survey			38.517362°	38.517355°
				-121.751778°	-121.752824°
DWR ID	DWR_ST0007_01_f_2018_34				
Comment Code					
Inspector Comment					
2017 Site ID: PUC 7.2 L					
Status: Eroding					
2017 Field Notes: New erosion along lower bank.					
Site History: 2011 - The toe to mid-bank is slumping. Large tree pop-outs have furthered the erosion. Slope is slightly steeper than 1:1.

View looking upstream at erosion at the waterside toe. Tree roots are exposed (September 2018).

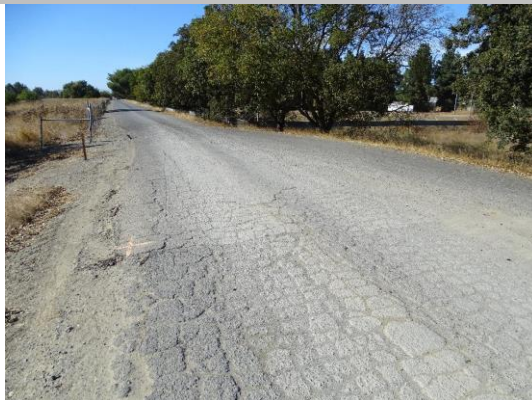
Photo 1 of 3 : UCIP\_FA\_2019\_55664\_82343.jpg

Comment Code					
Inspector Comment					
DS_ID:508 FS_ID:55664 EP_NO: 10247 Repair Type: Non-Urgent Crossing Status: Found UCIP Comments: 10/22/2019 No issues recorded during inspection (O.Yakimov - DWR UCIP) FIELD_STRUCT_DESC: 24-inch CIPP-lined drainage pipe of an unknown material through the levee, 11 feet below the crown. Flap gate on the waterside (WS) end. Concrete headwall on the landside (LS) end. Concrete Apron on the WS. (24-inch pipe [HLM 7.09] authorized under Automatic Board Order (ABO) issued as Permit No. 10247, 1974 - University of California, Office of the Regents). [Additional Reference(s): DWR Levee Log, 2005 (HLM 7.09). USACE Sacramento O&M Manual, Unit 119, December 1952, Revised 29 Dec 2016, (Station 172+00 PCT). USACE As-Built Drawing No. 50-04-2396, Revision 4, pdf page 25, Sheet 9, December 1947]. FS Date: 10/22/2019 1:55:30 PM

View of levee crown at the crossing

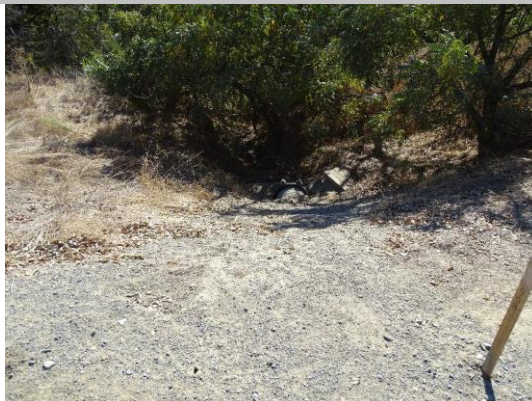
Photo 2 of 3 : UCIP\_FA\_2019\_55664\_82344.jpg

View of WS looking from levee crown

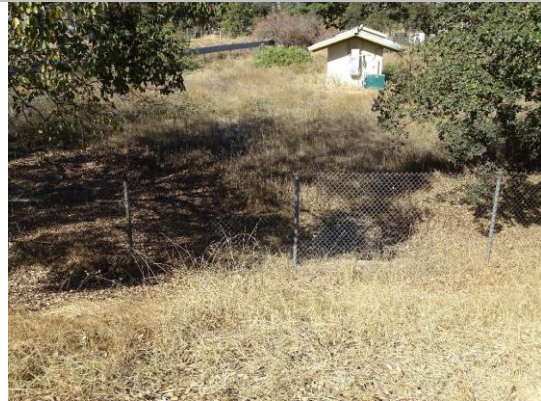
Photo 3 of 3 : UCIP\_FA\_2019\_55664\_82345.jpg

Comment Code						
Inspector Comment						
DS_ID:508 FS_ID:55664 EP_NO: 10247 Repair Type: Non-Urgent Crossing Status: Found UCIP Comments: 10/22/2019 No issues recorded during inspection (O.Yakimov - DWR UCIP) FIELD_STRUCT_DESC: 24-inch CIPP-lined drainage pipe of an unknown material through the levee, 11 feet below the crown. Flap gate on the waterside (WS) end. Concrete headwall on the landside (LS) end. Concrete Apron on the WS. (24-inch pipe [HLM 7.09] authorized under Automatic Board Order (ABO) issued as Permit No. 10247, 1974 - University of California, Office of the Regents). [Additional Reference(s): DWR Levee Log, 2005 (HLM 7.09). USACE Sacramento O&M Manual, Unit 119, December 1952, Revised 29 Dec 2016, (Station 172+00 PCT). USACE As-Built Drawing No. 50-04-2396, Revision 4, pdf page 25, Sheet 9, December 1947]. FS Date: 10/22/2019 1:55:30 PM

View of LS looking from levee crown

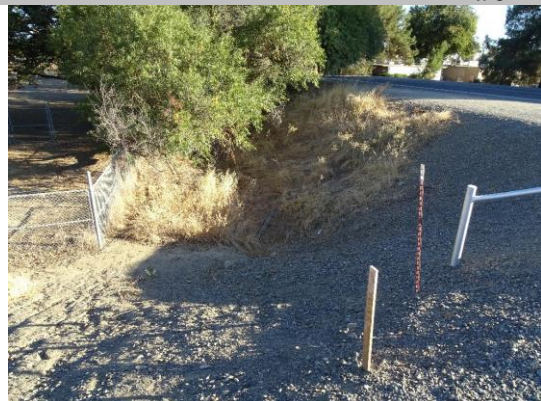
Photo 2 of 3 : UCIP\_FA\_2019\_55667\_82355.jpg

View of LS looking from levee crown

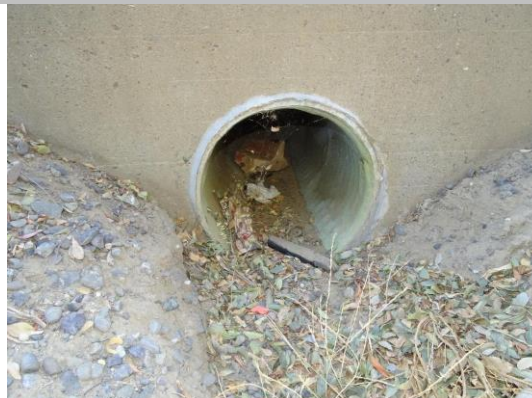
Photo 3 of 3 : UCIP\_FA\_2019\_55667\_82356.jpg

Comment Code						
Inspector Comment						
DS_ID:512 FS_ID:55667 EP_NO: 10247 Repair Type: Non-Urgent Crossing Status: Found UCIP Comments: 10/21/2019 No issues recorded during inspection (O.Yakimov - DWR UCIP)05/07/2013 Debris removed from outlet (C. Lund - DWR Sacramento Yard) 04/04/2012 Some debris blocking outlet. (W. Wylie - DWR UCIP) FIELD_STRUCT_DESC: 24-inch CIPP-lined drainage pipe of an unknown material through the levee, 12 feet below the crown. Flap gate on the waterside (WS) end. Concrete headwall on the landside (LS) end. (24-inch [HLM 7.36] authorized under Automatic Board Order (ABO) issued as Permit No. 10247, 1974 - University of California, Office of the Regents). [Additional Reference(s): DWR Levee Log, 2005 (HLM 7.36). USACE Sacramento O&M Manual, Unit 119, December 1952, Revised 29 Dec 2016, (Station 183+97 PCT). USACE As-Built Drawing No. 50-04-2396, Revision 4, pdf page 25, Sheet 9, December 1947]. FS Date: 10/21/2019 2:33:12 PM

LS levee slope, headwall, and pipe end

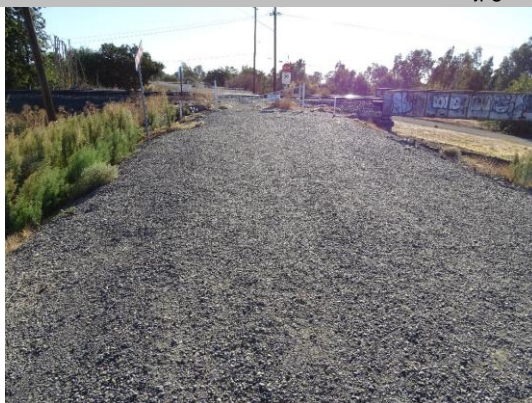
Photo 1 of 3 : UCIP\_FA\_2019\_55673\_82372.jpg

Comment Code						
Inspector Comment						
DS_ID:516 FS_ID:55673 EP_NO: 10260 Repair Type: Non-Urgent Crossing Status: Found UCIP Comments: 10/21/2019 No issues recorded during inspection (O.Yakimov - DWR UCIP)05/07/2013 Owner of pipe may have to clean sediment. (C. Lund - DWR Sacramento Yard) 04/05/2012 Pipe is partially obstructed with sedimentation. (W. Wylie - DWR UCIP) FIELD_STRUCT_DESC: 24-inch corrugated metal drainage pipe through the levee, 12 feet below the crown. Flap gate on the waterside (WS) end. (24-inch pipe [HLM 7.52] authorized under Automatic Board Order (ABO) issued as Permit No. 10260, 1974 - Southern Pacific Transportation Company). [Additional Reference(s): DWR Levee Log, 2005 (HLM 7.52). USACE Sacramento O&M Manual, Unit 119, December 1952, Revised 29 Dec 2016, (Station 193+20 PCT). USACE As-Built Drawing No. 50-04-2396, Revision 4, pdf page 25, Sheet 9, December 1947]. FS Date: 10/21/2019 4:00:06 PM

View of levee crown at the crossing

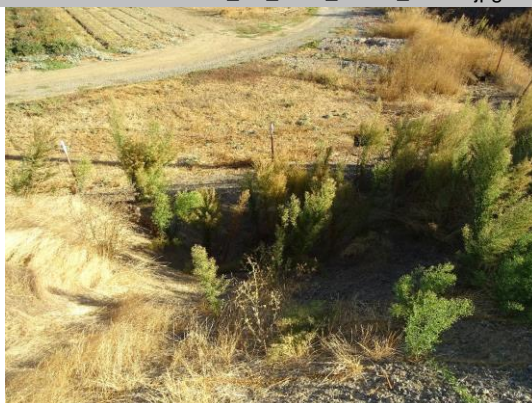
Photo 2 of 3 : UCIP\_FA\_2019\_55673\_82373.jpg

View of LS looking from levee crown

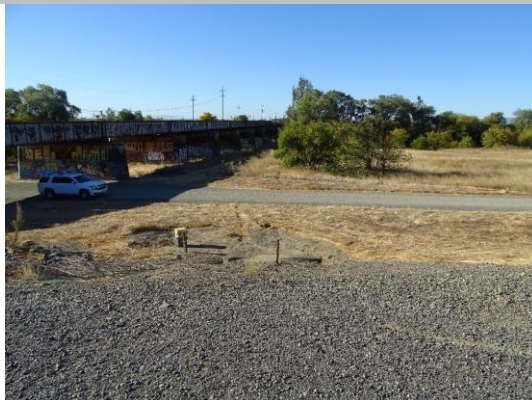
Photo 3 of 3 : UCIP\_FA\_2019\_55673\_82374.jpg

Comment Code						
Inspector Comment						
DS_ID:516 FS_ID:55673 EP_NO: 10260 Repair Type: Non-Urgent Crossing Status: Found UCIP Comments: 10/21/2019 No issues recorded during inspection (O.Yakimov - DWR UCIP)05/07/2013 Owner of pipe may have to clean sediment. (C. Lund - DWR Sacramento Yard) 04/05/2012 Pipe is partially obstructed with sedimentation. (W. Wylie - DWR UCIP) FIELD_STRUCT_DESC: 24-inch corrugated metal drainage pipe through the levee, 12 feet below the crown. Flap gate on the waterside (WS) end. (24-inch pipe [HLM 7.52] authorized under Automatic Board Order (ABO) issued as Permit No. 10260, 1974 - Southern Pacific Transportation Company). [Additional Reference(s): DWR Levee Log, 2005 (HLM 7.52). USACE Sacramento O&M Manual, Unit 119, December 1952, Revised 29 Dec 2016, (Station 193+20 PCT). USACE As-Built Drawing No. 50-04-2396, Revision 4, pdf page 25, Sheet 9, December 1947]. FS Date: 10/21/2019 4:00:06 PM

View of WS looking from levee crown

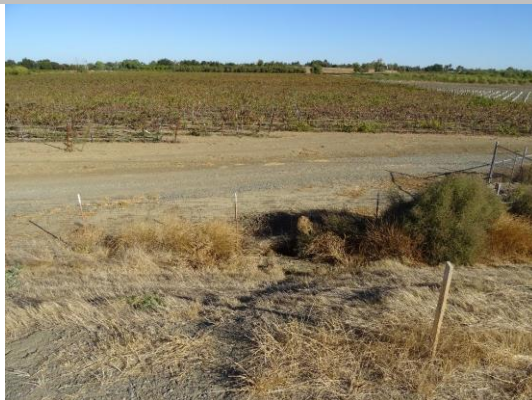
Photo 1 of 3 : UCIP\_FA\_2019\_55675\_82382.jpg

Comment Code					
Inspector Comment					
DS_ID:518 FS_ID:55675 EP_NO: 10247 Repair Type: Non-Urgent Crossing Status: Found UCIP Comments: 10/21/2019 Difficult access to pipe inlet on LS due to a fence. (O.Yakimov - DWR UCIP)05/07/2013 Fence blocking inlet. Owner of fence needs to move fence away from inlet. (C. Lund - DWR Sacramento Yard) 04/05/2012 Clear debris from pipe. (W. Wylie - DWR UCIP) FIELD_STRUCT_DESC: 24-inch CIPP-lined corrugated metal drainage pipe through the levee, 12 feet below the crown. Slide gate on the waterside (WS) slope, and headwalls on both sides. (24-inch pipe [HLM 7.75] authorized under Automatic Board Order (ABO) issued as Permit No. 10247, 1974 - University of California, Office of the Regents). [Additional Reference(s): DWR Levee Log, 2005 (HLM 7.75). USACE Sacramento O&M Manual, Unit 119, December 1952, Revised 29 Dec 2016, (Station 204+00 PCT). USACE As-Built Drawing No. 50-04-2396, Revision 4, pdf page 25, Sheet 9, December 1947]. FS Date: 10/21/2019 8:27:02 AM

View of LS looking from levee crown

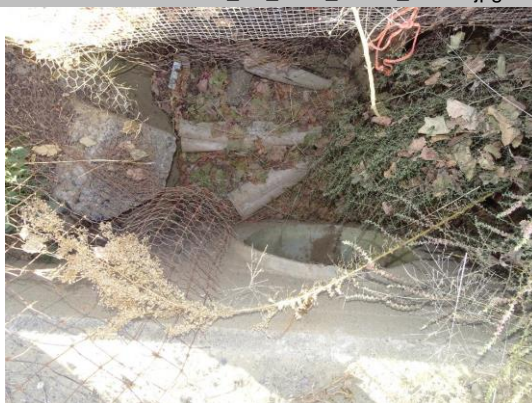
Photo 2 of 3 : UCIP\_FA\_2019\_55675\_82383.jpg

LS: headwall and pipe end near a fence

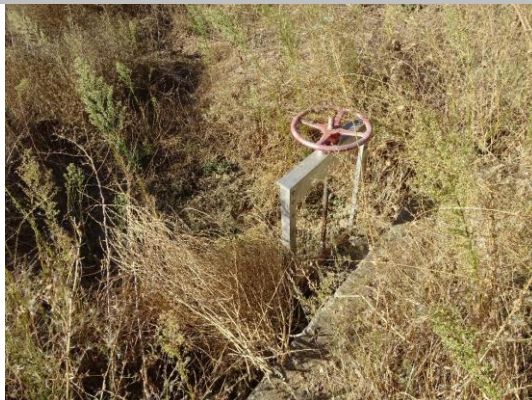
Photo 3 of 3 : UCIP\_FA\_2019\_55675\_82385.jpg

Comment Code						
Inspector Comment						
DS_ID:518 FS_ID:55675 EP_NO: 10247 Repair Type: Non-Urgent Crossing Status: Found UCIP Comments: 10/21/2019 Difficult access to pipe inlet on LS due to a fence. (O.Yakimov - DWR UCIP)05/07/2013 Fence blocking inlet. Owner of fence needs to move fence away from inlet. (C. Lund - DWR Sacramento Yard) 04/05/2012 Clear debris from pipe. (W. Wylie - DWR UCIP) FIELD_STRUCT_DESC: 24-inch CIPP-lined corrugated metal drainage pipe through the levee, 12 feet below the crown. Slide gate on the waterside (WS) slope, and headwalls on both sides. (24-inch pipe [HLM 7.75] authorized under Automatic Board Order (ABO) issued as Permit No. 10247, 1974 - University of California, Office of the Regents). [Additional Reference(s): DWR Levee Log, 2005 (HLM 7.75). USACE Sacramento O&M Manual, Unit 119, December 1952, Revised 29 Dec 2016, (Station 204+00 PCT). USACE As-Built Drawing No. 50-04-2396, Revision 4, pdf page 25, Sheet 9, December 1947]. FS Date: 10/21/2019 8:27:02 AM

WS: headwall and slide gate

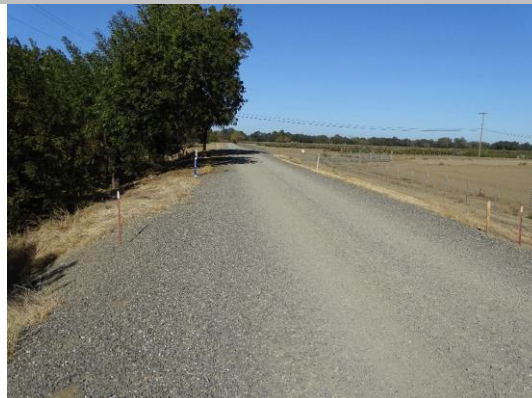
Photo 1 of 3 : UCIP\_FA\_2019\_55679\_82393.jpg

Comment Code						
Inspector Comment						
DS_ID:520						
FS_ID:55679						
EP_NO: 10247						
Repair Type: Non-Urgent						
Crossing Status: Found						
UCIP Comments: 10/21/2019 No issues recorded during inspection						
(O.Yakimov - DWR UCIP)05/07/2012 Cleaned inlet and outlets.						
Owner of pipe may need to clean pipe. (C. Lund - DWR Sacramento Yard)						
04/05/2012 Pipe is plugged with soil on LS. (W. Wylie - DWR UCIP)						
FIELD_STRUCT_DESC: 24-inch CIPP-lined corrugated metal drainage						
pipe through the levee, 8 feet below the crown. Slide gate on the						
waterside (WS) end. (24-inch pipe [HLM 8.45] authorized under						
Automatic Board Order (ABO) issued as Permit No. 10247, 1974 -						
University of California, Office of the Regents). [Additional Reference(s):						
DWR Levee Log, 2005 (HLM 8.45). USACE Sacramento O&M Manual,						
Unit 119, December 1952, Revised 29 Dec 2016, (Station 241+50

View of levee crown at the crossing

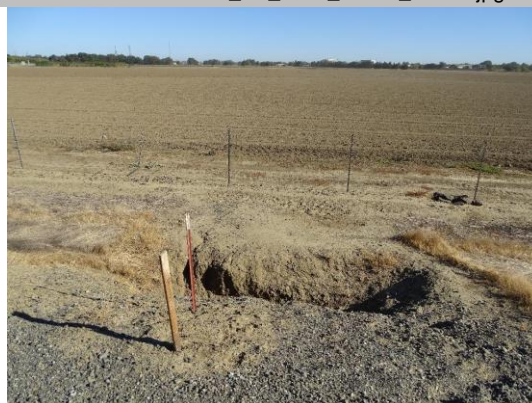
Photo 2 of 3 : UCIP\_FA\_2019\_55679\_82394.jpg

View of LS looking from levee crown

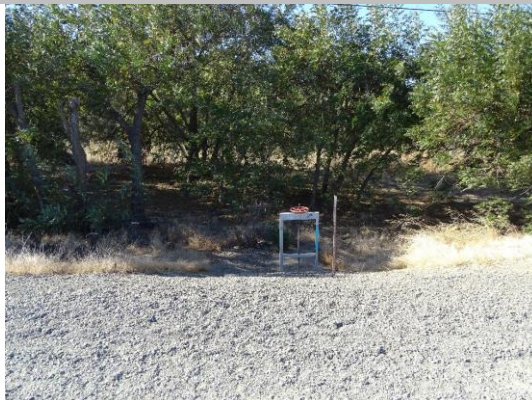
Photo 3 of 3 : UCIP\_FA\_2019\_55679\_82395.jpg

Comment Code						
Inspector Comment						
DS_ID:520 FS_ID:55679 EP_NO: 10247 Repair Type: Non-Urgent Crossing Status: Found UCIP Comments: 10/21/2019 No issues recorded during inspection (O.Yakimov - DWR UCIP)05/07/2012 Cleaned inlet and outlets. Owner of pipe may need to clean pipe. (C. Lund - DWR Sacramento Yard) 04/05/2012 Pipe is plugged with soil on LS. (W. Wylie - DWR UCIP) FIELD_STRUCT_DESC: 24-inch CIPP-lined corrugated metal drainage pipe through the levee, 8 feet below the crown. Slide gate on the waterside (WS) end. (24-inch pipe [HLM 8.45] authorized under Automatic Board Order (ABO) issued as Permit No. 10247, 1974 - University of California, Office of the Regents). [Additional Reference(s): DWR Levee Log, 2005 (HLM 8.45). USACE Sacramento O&M Manual, Unit 119, December 1952, Revised 29 Dec 2016, (Station 241+50 PCT). USACE As-Built Drawing No. 50-04-2396, Revision 2, pdf page 26, Sheet 10, December 1947]. FS Date: 10/21/2019 10:02:10 AM

View of WS looking from levee crown

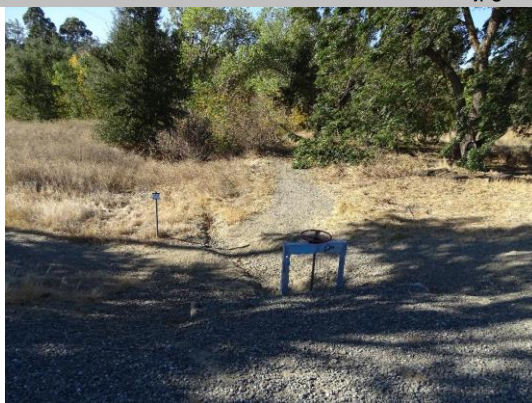
Photo 1 of 3 : UCIP\_FA\_2019\_55680\_82398.jpg

Comment Code					
Inspector Comment					
DS_ID:521 FS_ID:55680 EP_NO: 10247 Repair Type: Non-Urgent Crossing Status: Found UCIP Comments: 10/21/2019 No issues recorded during inspection (O.Yakimov - DWR UCIP)05/07/2013 Removed material at slidegate and inlet. (C. Lund - DWR Sacramento Yard) 04/05/2012 Pipe is partially blocked by sedimentation and slide gate will not open. (W. Wylie - DWR UCIP) FIELD_STRUCT_DESC: 24-inch CIPP-lined corrugated metal drainage pipe through the levee, 7 feet below the crown. Slide gate on the waterside (WS) end. Headwalls on both ends. (24-inch pipe [HLM 8.50] authorized under Automatic Board Order (ABO) issued as Permit No. 10247, 1974 - University of California, Office of the Regents. Also mentioned in Permit No. 5896, 1967 - The Regents of the University of California, Office of Architects and Engineers, University of California, Davis Campus). [Additional Reference(s): DWR Levee Log, 2005 (HLM 8.50). USACE Sacramento O&M Manual, Unit 119, December 1952, Revised 29 Dec 2016, (Station 244+20 PCT). USACE As-Built Drawing No. 50-04-2396, Revision 2, pdf page 26, Sheet 10, December 1947]. FS Date: 10/21/2019 11:46:58 AM

View of WS looking from levee crown

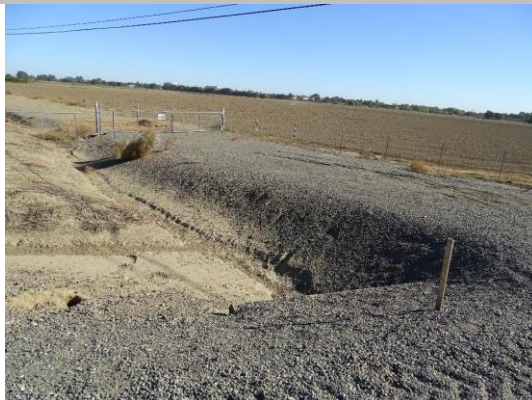
Photo 2 of 3 : UCIP\_FA\_2019\_55680\_82399.jpg

View of LS looking from levee crown

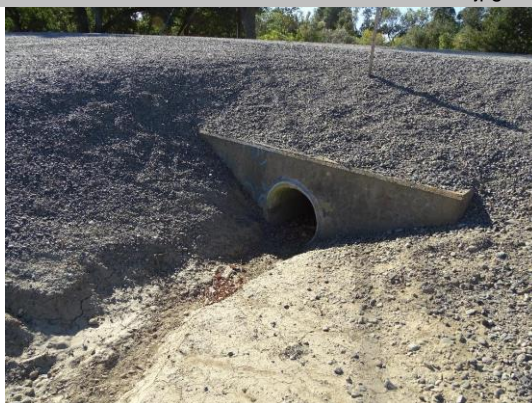
Photo 3 of 3 : UCIP\_FA\_2019\_55680\_82400.jpg

Comment Code						
Inspector Comment						
DS_ID:521 FS_ID:55680 EP_NO: 10247 Repair Type: Non-Urgent Crossing Status: Found UCIP Comments: 10/21/2019 No issues recorded during inspection (O.Yakimov - DWR UCIP)05/07/2013 Removed material at slidegate and inlet. (C. Lund - DWR Sacramento Yard) 04/05/2012 Pipe is partially blocked by sedimentation and slide gate will not open. (W. Wylie - DWR UCIP) FIELD_STRUCT_DESC: 24-inch CIPP-lined corrugated metal drainage pipe through the levee, 7 feet below the crown. Slide gate on the waterside (WS) end. Headwalls on both ends. (24-inch pipe [HLM 8.50] authorized under Automatic Board Order (ABO) issued as Permit No. 10247, 1974 - University of California, Office of the Regents. Also mentioned in Permit No. 5896, 1967 - The Regents of the University of California, Office of Architects and Engineers, University of California, Davis Campus). [Additional Reference(s): DWR Levee Log, 2005 (HLM 8.50). USACE Sacramento O&M Manual, Unit 119, December 1952, Revised 29 Dec 2016, (Station 244+20 PCT). USACE As-Built Drawing No. 50-04-2396, Revision 2, pdf page 26, Sheet 10, December 1947]. FS Date: 10/21/2019 11:46:58 AM

LS levee slope, headwall, and pipe end

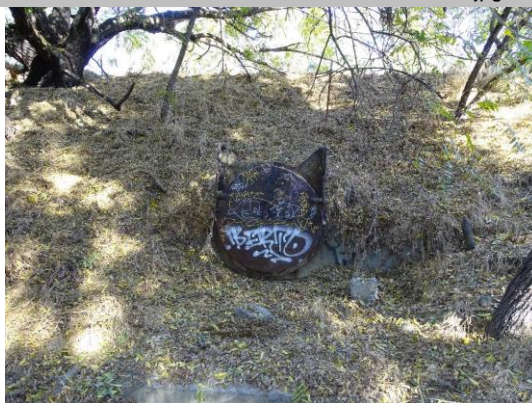
Photo 1 of 3 : UCIP\_FA\_2019\_55684\_82410.jpg

Comment Code						
Inspector Comment						
DS_ID:523 FS_ID:55684 EP_NO: 10247 Repair Type: Non-Urgent Crossing Status: Found UCIP Comments: 10/21/2019 Pipe inlet is closed with steel plate bolted to headwall in drainage canal on LS. (O.Yakimov - DWR UCIP) FIELD_STRUCT_DESC: *ABANDONED* 48-inch drainage pipe of an unknown material through the levee, 15 feet below the crown. Steel plate installed over inlet off the landside (LS) toe. Pipe not grouted. Flap gate on waterside (WS) end. Headwalls on both ends. (48-inch pipe [HLM 8.88] authorized under Automatic Board Order (ABO) issued as Permit No. 10247, 1974 - University of California, Office of the Regents). [Additional Reference(s): DWR Levee Log, 2005 (HLM 8.88). USACE Sacramento O&M Manual, Unit 119, December 1952, Revised 29 Dec 2016, (Station 262+30 PCT), 48-inch pipe referenced. USACE As-Built Drawing No. 50-04-2396, Revision 2, pdf page 26, Sheet 10, 24-inch pipe referenced on levee alignment, December 1947]. FS Date: 10/21/2019 1:46:45 PM

WS levee slope, headwall, and flap gate

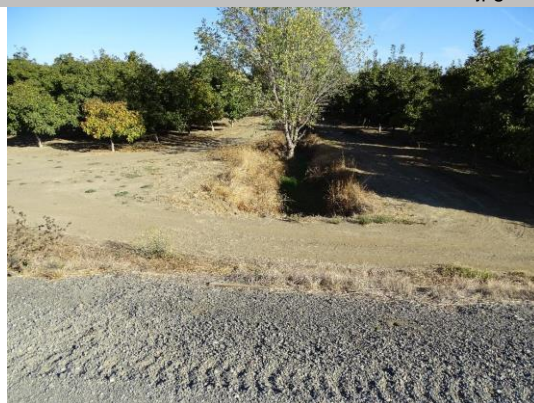
Photo 1 of 3 : UCIP\_FA\_2019\_55424\_81638.jpg

Comment Code						
Inspector Comment						
DS_ID:16621 FS_ID:55424 EP_NO: 10270 Repair Type: Non-Urgent Crossing Status: Found UCIP Comments: 10/22/2019 Crossing visually is in good condition. 12-inch diameter through hole has developed due to soil instability on WS berm visible on the top of pipe outlet embankment. (O.Yakimov - DWR UCIP) FIELD_STRUCT_DESC: 36-inch corrugated metal drainage pipe through the levee, 14 feet below the crown. Flap gate on the waterside (WS) end. Concrete headwall on the landside (LS) end. (36-inch pipe [HLM 0.85] authorized under Automatic Board Order (ABO) issued as Permit No. 10270, 1974 - Hamel). [Additional Reference(s): DWR Levee Log, 2005 (HLM 0.85). USACE Sacramento O&M Manual, Unit 119, December 1952, Revised 29 Dec 2016, (Station T 1+45). USACE As-Built Drawing No. 50-04-2396, Revision 1, pdf page 21, Sheet 5, December 1947]. FS Date: 10/22/2019 9:59:31 AM

View of WS looking from levee crown

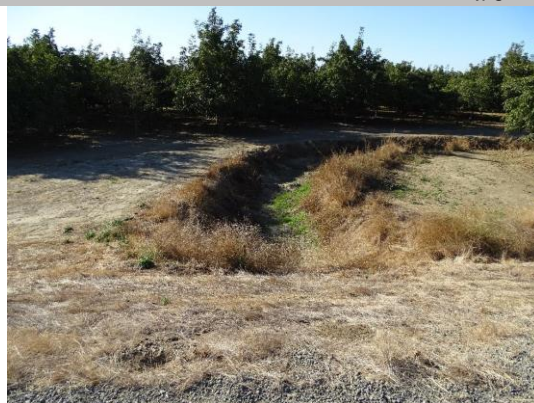
Photo 2 of 3 : UCIP\_FA\_2019\_55424\_81639.jpg

View of LS looking from levee crown

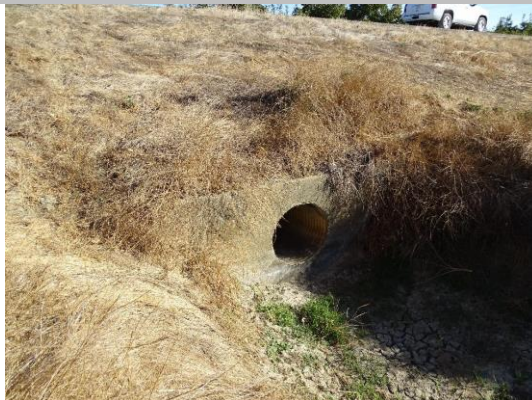
Photo 3 of 3 : UCIP\_FA\_2019\_55424\_81640.jpg

Comment Code						
Inspector Comment						
DS_ID:16621 FS_ID:55424 EP_NO: 10270 Repair Type: Non-Urgent Crossing Status: Found UCIP Comments: 10/22/2019 Crossing visually is in good condition. 12-inch diameter through hole has developed due to soil instability on WS berm visible on the top of pipe outlet embankment. (O.Yakimov - DWR UCIP) FIELD_STRUCT_DESC: 36-inch corrugated metal drainage pipe through the levee, 14 feet below the crown. Flap gate on the waterside (WS) end. Concrete headwall on the landside (LS) end. (36-inch pipe [HLM 0.85] authorized under Automatic Board Order (ABO) issued as Permit No. 10270, 1974 - Hamel). [Additional Reference(s): DWR Levee Log, 2005 (HLM 0.85). USACE Sacramento O&M Manual, Unit 119, December 1952, Revised 29 Dec 2016, (Station T 1+45). USACE As-Built Drawing No. 50-04-2396, Revision 1, pdf page 21, Sheet 5, December 1947]. FS Date: 10/22/2019 9:59:31 AM

Headwall and pipe at LS toe

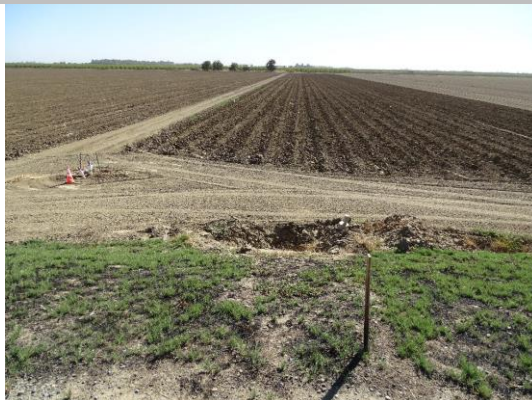
Photo 1 of 3 : UCIP\_FA\_2019\_55411\_81619.jpg

Comment Code					
Inspector Comment					
DS_ID:16625 FS_ID:55411 EP_NO: 10277 Repair Type: Urgent Crossing Status: Found UCIP Comments: 10/21/2019 A PVC pipe runs through a drainage pipe from LS to WS levee toe. Slide gate cannot be closed properly to prevent flooding on LS. Remove PVC pipe. (O.Yakimov - DWR UCIP) FIELD_STRUCT_DESC: 24-inch CIPP-lined corrugated metal drainage pipe through the levee, 9 feet below the crown. Slide gate on the waterside (WS) slope. Concrete headwalls on both ends. (24-inch pipe [HLM 2.71] authorized under Automatic Board Order (ABO) issued as Permit No. 10277, 1974 - Naomi Schoeningh). [Additional Reference(s): DWR Levee Log, 2005 (HLM 2.71). USACE Sacramento O&M Manual, Unit 119, December 1952, Revised 29 Dec 2016, (Station 30+15 PCT). USACE As-Built Drawing No. 50-04-2396, Revision 4, pdf page 23, Sheet 7, December 1947]. FS Date: 10/21/2019 11:18:53 AM

View of LS from levee crown

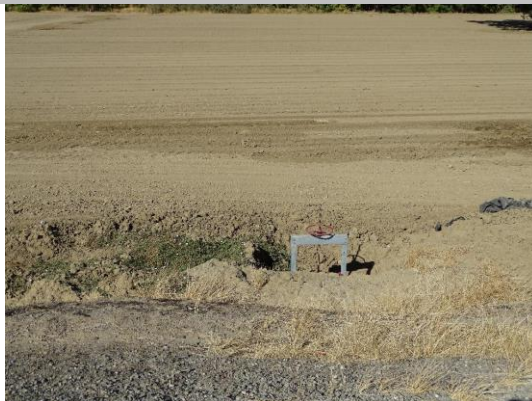
Photo 2 of 3 : UCIP\_FA\_2019\_55411\_81620.jpg

View of WS from levee crown

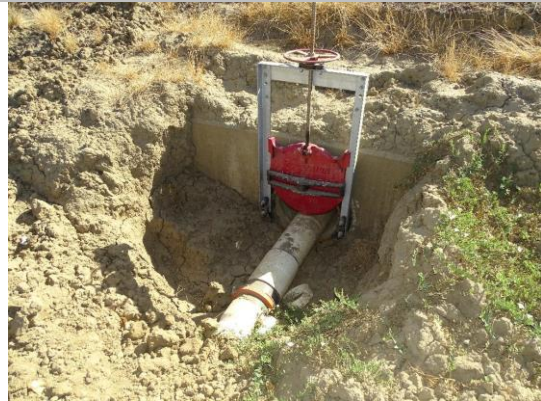
Photo 3 of 3 : UCIP\_FA\_2019\_55411\_81621.jpg

Comment Code						
Inspector Comment						
DS_ID:16625 FS_ID:55411 EP_NO: 10277 Repair Type: Urgent Crossing Status: Found UCIP Comments: 10/21/2019 A PVC pipe runs through a drainage pipe from LS to WS levee toe. Slide gate cannot be closed properly to prevent flooding on LS. Remove PVC pipe. (O.Yakimov - DWR UCIP) FIELD_STRUCT_DESC: 24-inch CIPP-lined corrugated metal drainage pipe through the levee, 9 feet below the crown. Slide gate on the waterside (WS) slope. Concrete headwalls on both ends. (24-inch pipe [HLM 2.71] authorized under Automatic Board Order (ABO) issued as Permit No. 10277, 1974 - Naomi Schoeningh). [Additional Reference(s): DWR Levee Log, 2005 (HLM 2.71). USACE Sacramento O&M Manual, Unit 119, December 1952, Revised 29 Dec 2016, (Station 30+15 PCT). USACE As-Built Drawing No. 50-04-2396, Revision 4, pdf page 23, Sheet 7, December 1947]. FS Date: 10/21/2019 11:18:53 AM

Headwall and slidegate at WS toe with a PVC pipe running through

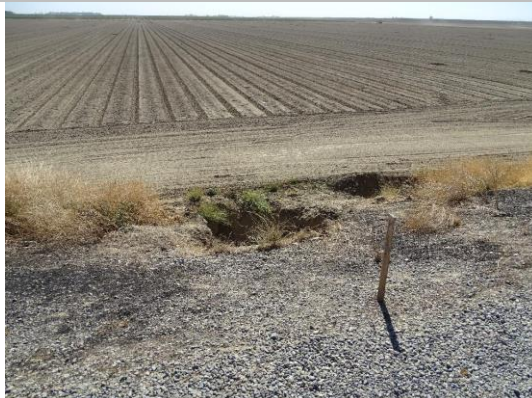
Photo 1 of 3 : UCIP\_FA\_2019\_55412\_81623.jpg

Comment Code					
Inspector Comment					
DS_ID:16626 FS_ID:55412 EP_NO: 10277 Repair Type: Urgent Crossing Status: Found UCIP Comments: 10/21/2019 A PVC pipe runs through a drainage pipe from LS to WS levee toe. Slide gate cannot be closed properly to prevent flooding on LS. Remove PVC pipe. (O.Yakimov - DWR UCIP) FIELD_STRUCT_DESC: 24-inch CIPP-lined corrugated metal drainage pipe through the levee, 9 feet below the crown. Slide gate on the waterside (WS) slope, and headwalls on both sides. (24-inch pipe [HLM 3.11] authorized under Automatic Board Order (ABO) issued as Permit No. 10277, 1974 - Naomi Schoeningh). [Additional Reference(s): DWR Levee Log, 2005 (HLM 3.11). USACE Sacramento O&M Manual, Unit 119, December 1952, Revised 29 Dec 2016, (Station 50+72 PCT). USACE As-Built Drawing No. 50-04-2396, Revision 4, pdf page 23, Sheet 7, December 1947]. FS Date: 10/21/2019 1:30:39 PM

View of LS from levee crown

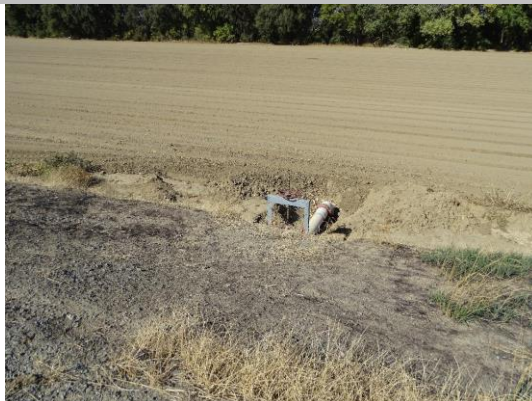
Photo 2 of 3 : UCIP\_FA\_2019\_55412\_81624.jpg

View of WS from levee crown

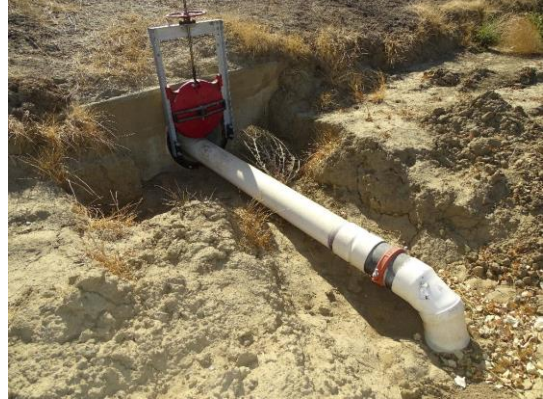
Photo 3 of 3 : UCIP\_FA\_2019\_55412\_81625.jpg

Comment Code						
Inspector Comment						
DS_ID:16626 FS_ID:55412 EP_NO: 10277 Repair Type: Urgent Crossing Status: Found UCIP Comments: 10/21/2019 A PVC pipe runs through a drainage pipe from LS to WS levee toe. Slide gate cannot be closed properly to prevent flooding on LS. Remove PVC pipe. (O.Yakimov - DWR UCIP) FIELD_STRUCT_DESC: 24-inch CIPP-lined corrugated metal drainage pipe through the levee, 9 feet below the crown. Slide gate on the waterside (WS) slope, and headwalls on both sides. (24-inch pipe [HLM 3.11] authorized under Automatic Board Order (ABO) issued as Permit No. 10277, 1974 - Naomi Schoeningh). [Additional Reference(s): DWR Levee Log, 2005 (HLM 3.11). USACE Sacramento O&M Manual, Unit 119, December 1952, Revised 29 Dec 2016, (Station 50+72 PCT). USACE As-Built Drawing No. 50-04-2396, Revision 4, pdf page 23, Sheet 7, December 1947]. FS Date: 10/21/2019 1:30:39 PM

Headwall and slidegate at WS toe with a PVC pipe running through

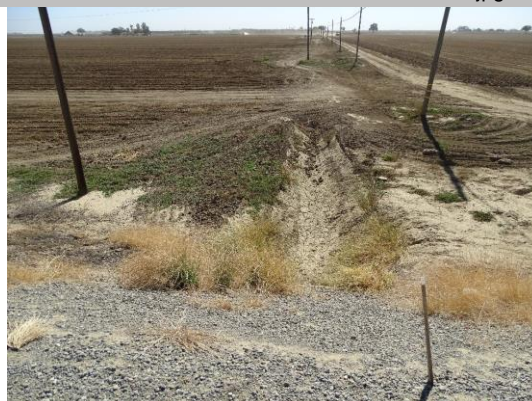
Photo 1 of 3 : UCIP\_FA\_2019\_55434\_81690.jpg

Comment Code					
Inspector Comment					
DS_ID:16629 FS_ID:55434 EP_NO: 10269 Repair Type: Non-Urgent Crossing Status: Found UCIP Comments: 10/21/2019 Pipe is partially silted, cleanup pipe. (O.Yakimov - DWR UCIP) FIELD_STRUCT_DESC: 24-inch CIPP-lined corrugated metal drainage pipe through the levee, 12.5 feet below the crown. Slide gate on the waterside (WS) end. Concrete headwalls on both ends. (24-inch pipe [HLM 4.26] authorized under Automatic Board Order (ABO) issued as Permit No. 10269, 1974 - Joseph Fahn). [Additional Reference(s): DWR Levee Log, 2005 (HLM 4.26). USACE Sacramento O&M Manual, Unit 119, December 1952, Revised 29 Dec 2016, (Station 109+75 PCT). USACE As-Built Drawing No. 50-04-2396, Revision 4, pdf page 24, Sheet 8, December 1947]. FS Date: 10/21/2019 9:16:52 AM

View of LS looking from levee crown

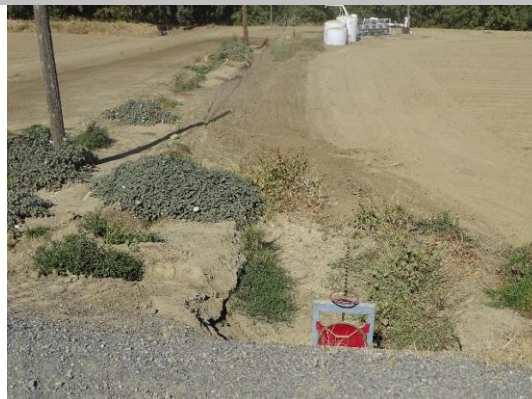
Photo 2 of 3 : UCIP\_FA\_2019\_55434\_81691.jpg

View of WS looking from levee crown

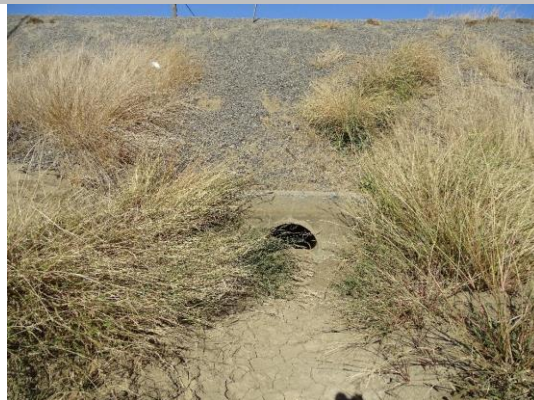
Photo 3 of 3 : UCIP\_FA\_2019\_55434\_81688.jpg

Comment Code						
Inspector Comment						
DS_ID:16629 FS_ID:55434 EP_NO: 10269 Repair Type: Non-Urgent Crossing Status: Found UCIP Comments: 10/21/2019 Pipe is partially silted, cleanup pipe. (O.Yakimov - DWR UCIP) FIELD_STRUCT_DESC: 24-inch CIPP-lined corrugated metal drainage pipe through the levee, 12.5 feet below the crown. Slide gate on the waterside (WS) end. Concrete headwalls on both ends. (24-inch pipe [HLM 4.26] authorized under Automatic Board Order (ABO) issued as Permit No. 10269, 1974 - Joseph Fahn). [Additional Reference(s): DWR Levee Log, 2005 (HLM 4.26). USACE Sacramento O&M Manual, Unit 119, December 1952, Revised 29 Dec 2016, (Station 109+75 PCT). USACE As-Built Drawing No. 50-04-2396, Revision 4, pdf page 24, Sheet 8, December 1947]. FS Date: 10/21/2019 9:16:52 AM

LS slope, headwall and pipe at levee toe

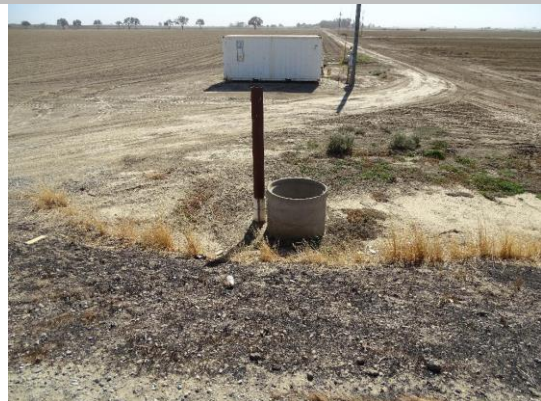
Photo 1 of 3 : UCIP\_FA\_2019\_55436\_81697.jpg

Comment Code					
Inspector Comment					
DS_ID:16644 FS_ID:55436 EP_NO: 10271 Repair Type: Non-Urgent Crossing Status: Found UCIP Comments: 10/21/2019 No issues recorded during inspection (O.Yakimov - DWR UCIP) FIELD_STRUCT_DESC: 24-inch corrugated metal drainage pipe through the levee, 9.5 feet below the crown. Flap gate on the waterside (WS). 36-inch standpipe on the landside (LS). (24-inch pipe [HLM 4.77] authorized under Automatic Board Order (ABO) issued as Permit No. 10271, 1974 - Ray H. Hamel). [Additional Reference(s): DWR Levee Log, 2005 (HLM 4.77). USACE Sacramento O&M Manual, Unit 119, December 1952, Revised 29 Dec 2016, (Station 136+40 PCT). USACE As-Built Drawing No. 50-04-2396, Revision 4, pdf page 24, Sheet 8, December 1947]. FS Date: 10/21/2019 9:46:01 AM

View of LS looking from levee crown. 36-inch standpipe near levee toe

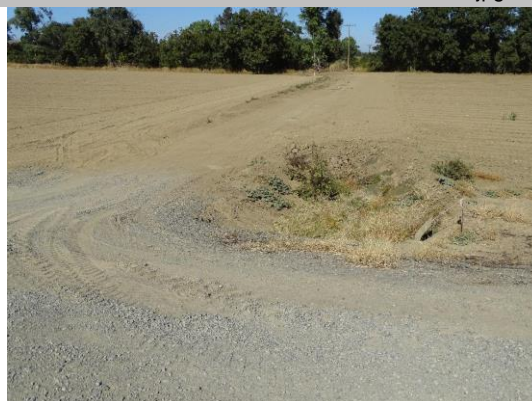
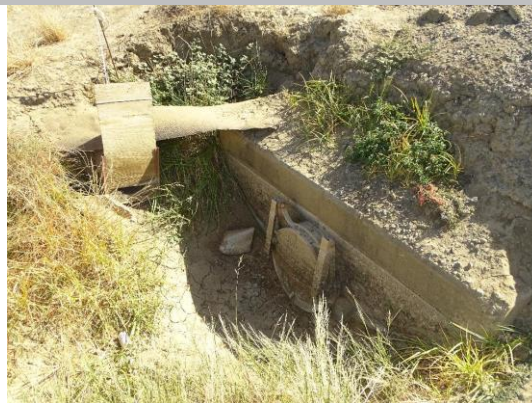
Photo 2 of 3 : UCIP\_FA\_2019\_55436\_81698.jpg

Comment Code						
Inspector Comment						
DS_ID:16644 FS_ID:55436 EP_NO: 10271 Repair Type: Non-Urgent Crossing Status: Found UCIP Comments: 10/21/2019 No issues recorded during inspection (O.Yakimov - DWR UCIP) FIELD_STRUCT_DESC: 24-inch corrugated metal drainage pipe through the levee, 9.5 feet below the crown. Flap gate on the waterside (WS). 36-inch standpipe on the landside (LS). (24-inch pipe [HLM 4.77] authorized under Automatic Board Order (ABO) issued as Permit No. 10271, 1974 - Ray H. Hamel). [Additional Reference(s): DWR Levee Log, 2005 (HLM 4.77). USACE Sacramento O&M Manual, Unit 119, December 1952, Revised 29 Dec 2016, (Station 136+40 PCT). USACE As-Built Drawing No. 50-04-2396, Revision 4, pdf page 24, Sheet 8, December 1947]. FS Date: 10/21/2019 9:46:01 AM

View of WS looking from levee crown

Headwall and flap gate at WS levee toe

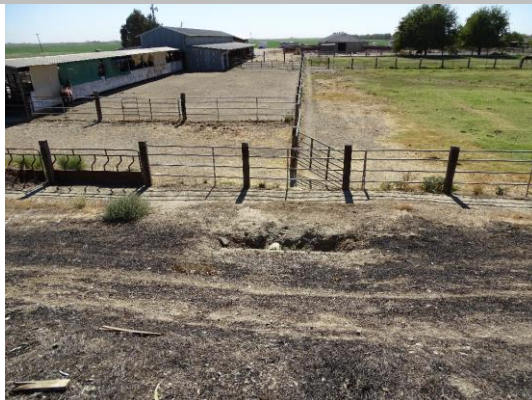
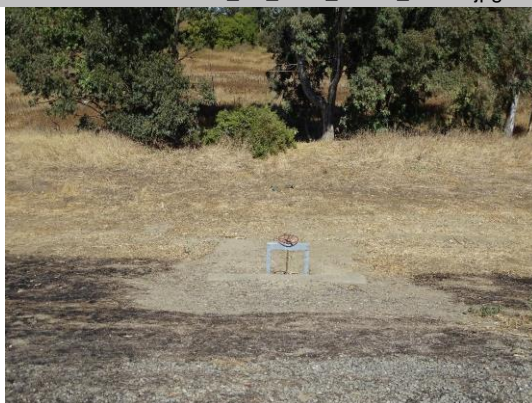
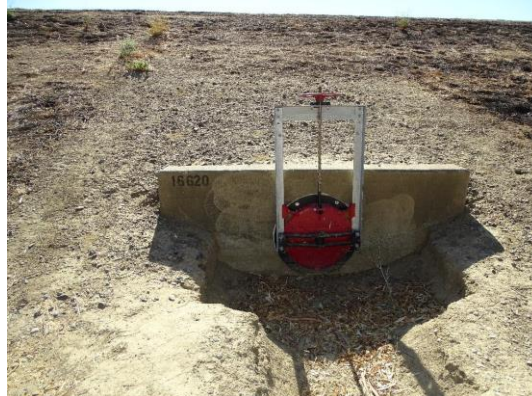
Photo 1 of 3 : UCIP\_FA\_2019\_55439\_81707.jpg

View of LS looking from levee crown

View of WS looking from levee crown

Comment Code						
Inspector Comment						
DS_ID:16620 FS_ID:55439 EP_NO: 10267 Repair Type: Non-Urgent Crossing Status: Found UCIP Comments: 10/21/2019 No issues recorded during inspection (O.Yakimov - DWR UCIP)05/22/2013 Gate has been oiled and debris removed from outlet on land side. (C. Lund - DWR Sacramento Yard) 04/06/2012 Pipe is partially filled with sediment and slide gate is in need of maintenance as it will not move. (W. Wylie - DWR UCIP) FIELD_STRUCT_DESC: 24-inch CIPP-lined corrugated metal drainage pipe through the levee, 13 feet below the crown. Slide gate on the waterside (WS) slope. Concrete headwalls on both ends. (24-inch pipe [HLM 5.56] authorized under Automatic Board Order (ABO) issued as Permit No. 10267, 1974 - Davis Laboratories, Inc.). [Additional Reference(s): DWR Levee Log, 2005 (HLM 5.56). USACE Sacramento O&M Manual, Unit 119, December 1952, Revised 29 Dec 2016, (Station 177+60 PCT). USACE As-Built Drawing No. 50-04-2396, Revision 4, pdf page 25, Sheet 9, December 1947]. FS Date: 10/21/2019 11:46:42 AM

WS levee slope, headwall and slide gate
